Final
DECISION DOCUMENT
UST SITE 120

117th Refueling Wing
Alabama Air National Guard
Birmingham Airport
Birmingham, Alabama

January 1997

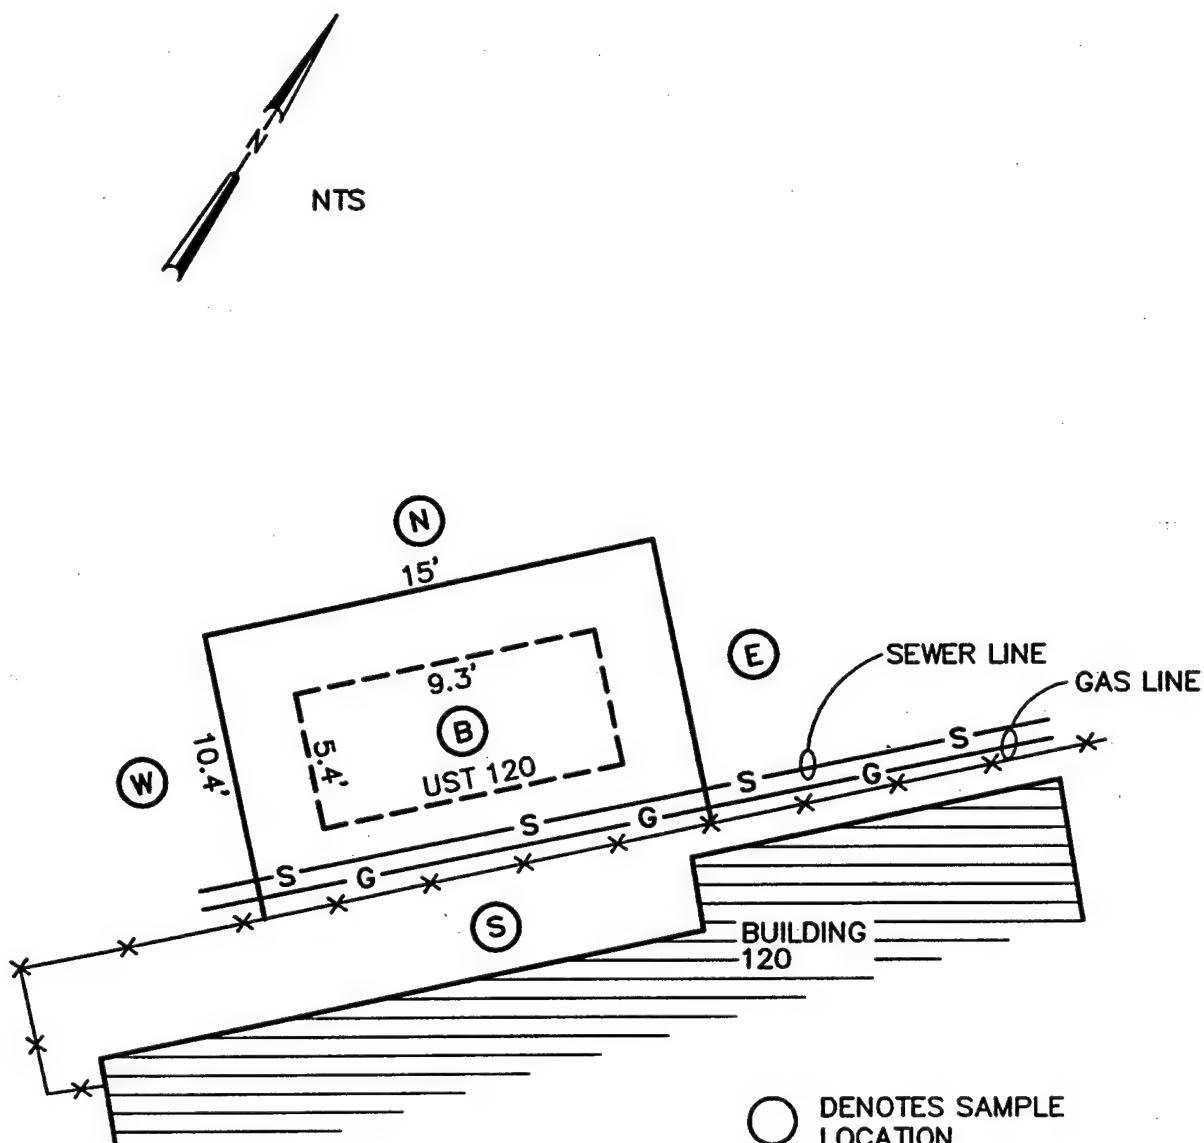
FIGURE 3
UST 120 SITE MAP
Alabama Air National Guard, Birmingham, Alabama

UST 120 appeared to be in good condition upon removal, although it had holes on the top of the western end. A septic odor was detected in the top 30 inches of soils removed from the tank pit. These odors were assumed to be the direct result of a clay field drain found on the southern edge of the excavation. No other soil staining or odors were observed during tank removal.

HNu HEADSPACE READING

LOCATION	(ppm)
120-N	9.4
120-S	15.8
120-E	6.8
120-W	7.4
120-B	6.6
120-SP	20.0

The soil in the UST pit was a reddish-orange clay with intermittent rock fragments. These clays were overlain by 18 inches of rock fill plus asphalt pavement. Moisture in the soils increased with depth, but the static water table is believed to be deeper than the pit bottom (9.5 feet).

Field screening tests (headspace readings) for the soils remaining in the excavation did not indicate soil contamination, and the excavation was backfilled. No soil was removed from the excavation for offsite disposal.
